# RESTORING CATTLE POINT: Existing Vegetation & Park Use

By P.T. de Greeff Ltd. Landscape Architecture  
March 27, 2022

# RESTORING CATTLE POINT: Maritime Meadow Restoration

# RESTORING CATTLE POINT: Concept Sketch

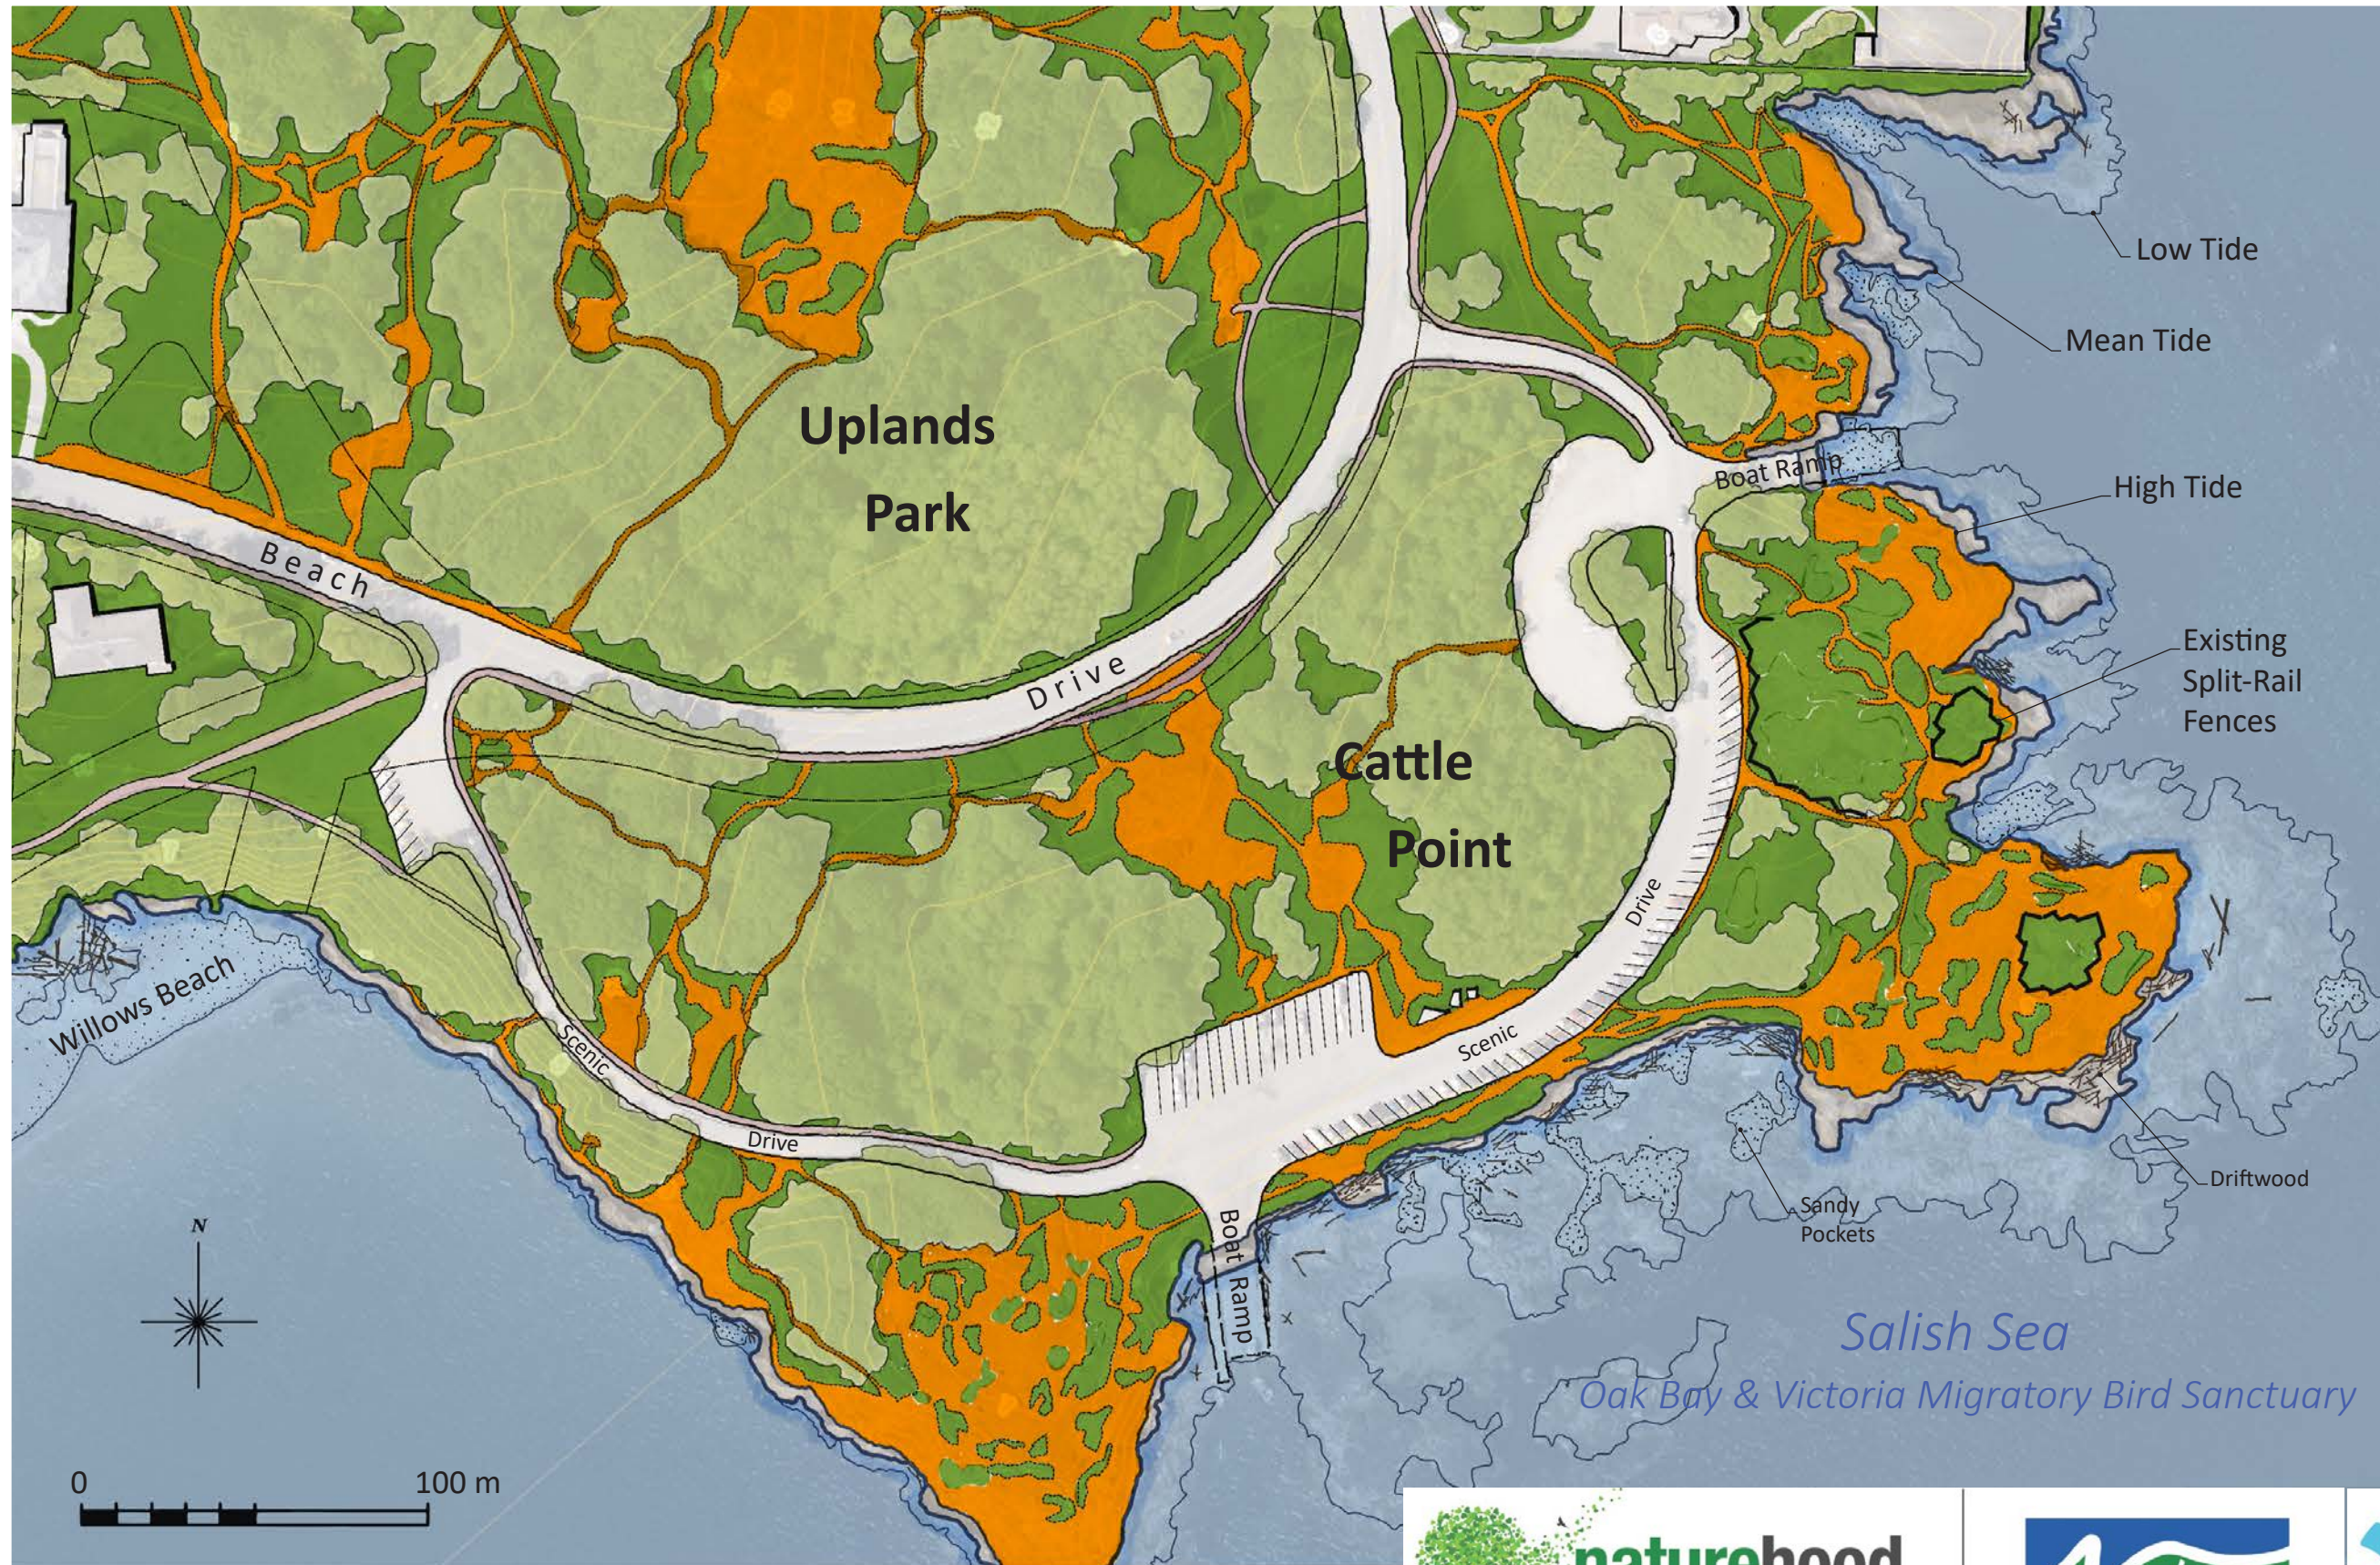
## LEGEND:

Existing tree cover
-

Existing lawn & meadow
-

Informal trails & meadow areas impacted by foot traffic

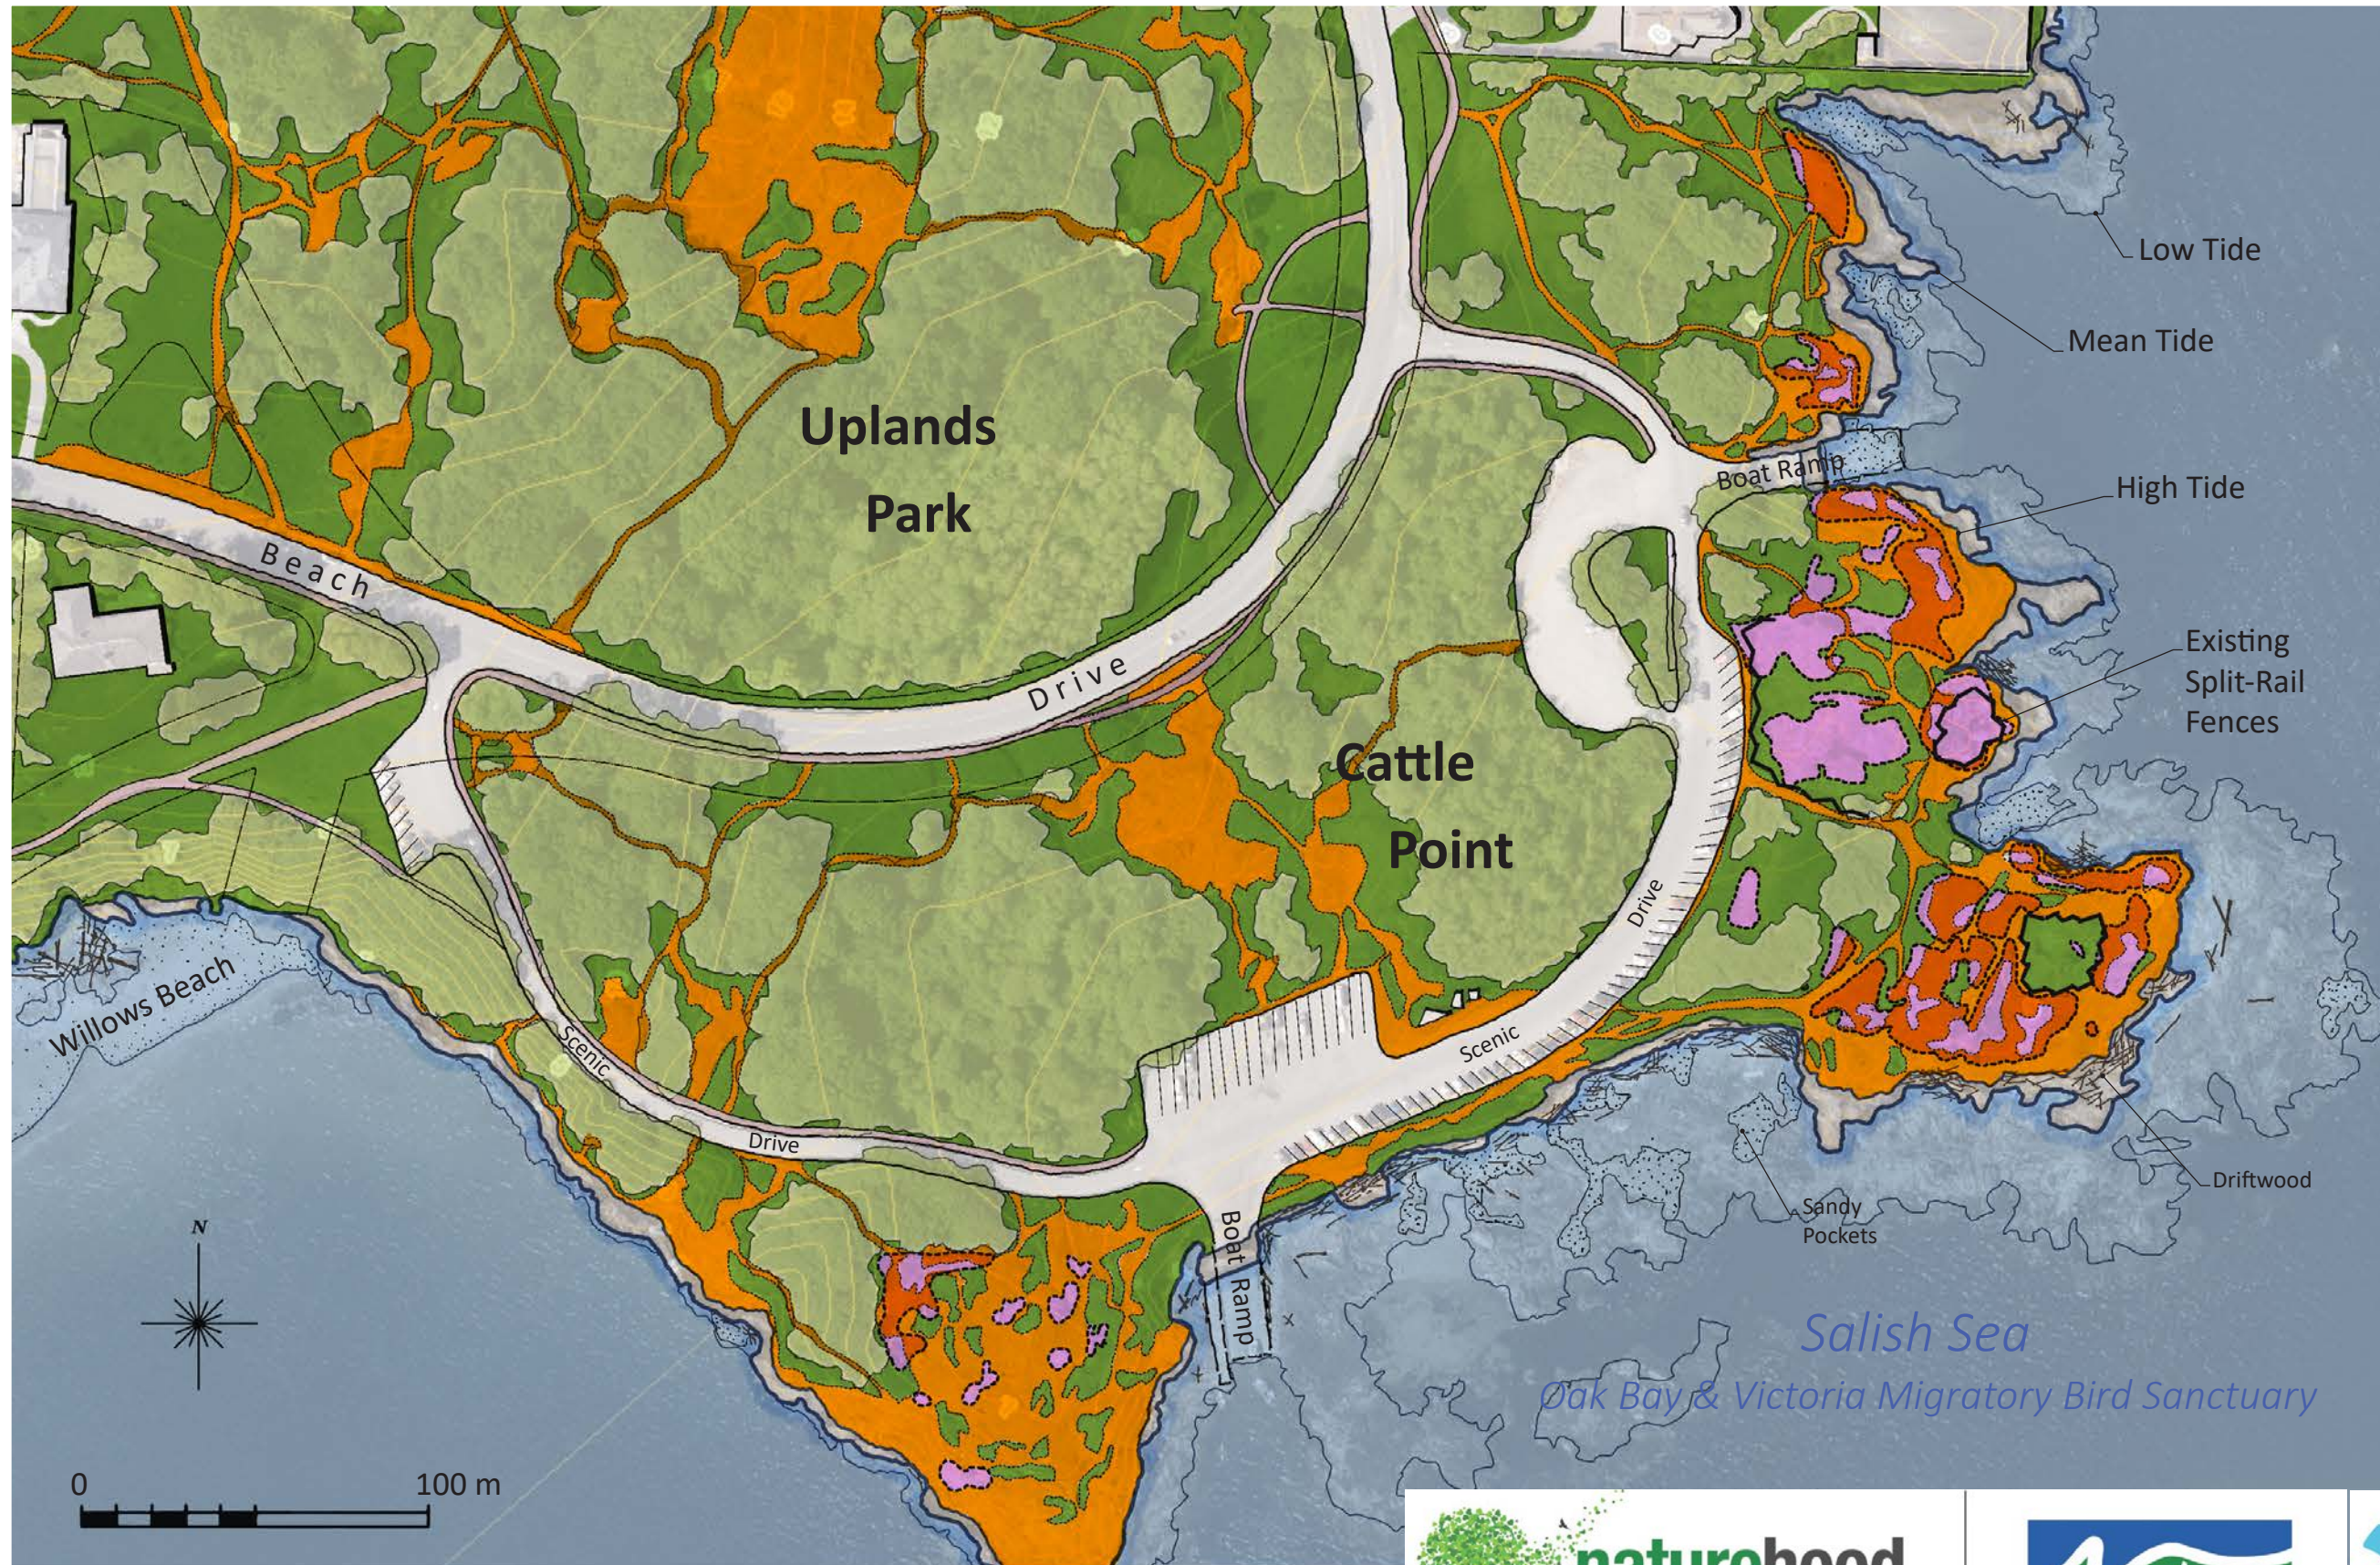
-   Existing tree cover
-   Existing lawn & meadow
-   Informal trails & meadow areas impacted by foot traffic
-   Known Red-listed Plant Species Areas\*

Wylie Thomas, Naturalist. 2021 Distribution of Three of Cattle Point's Seven Species at Risk: Coast Microseris, Bearded Owl-Clover & Macoun's Meadowfoam

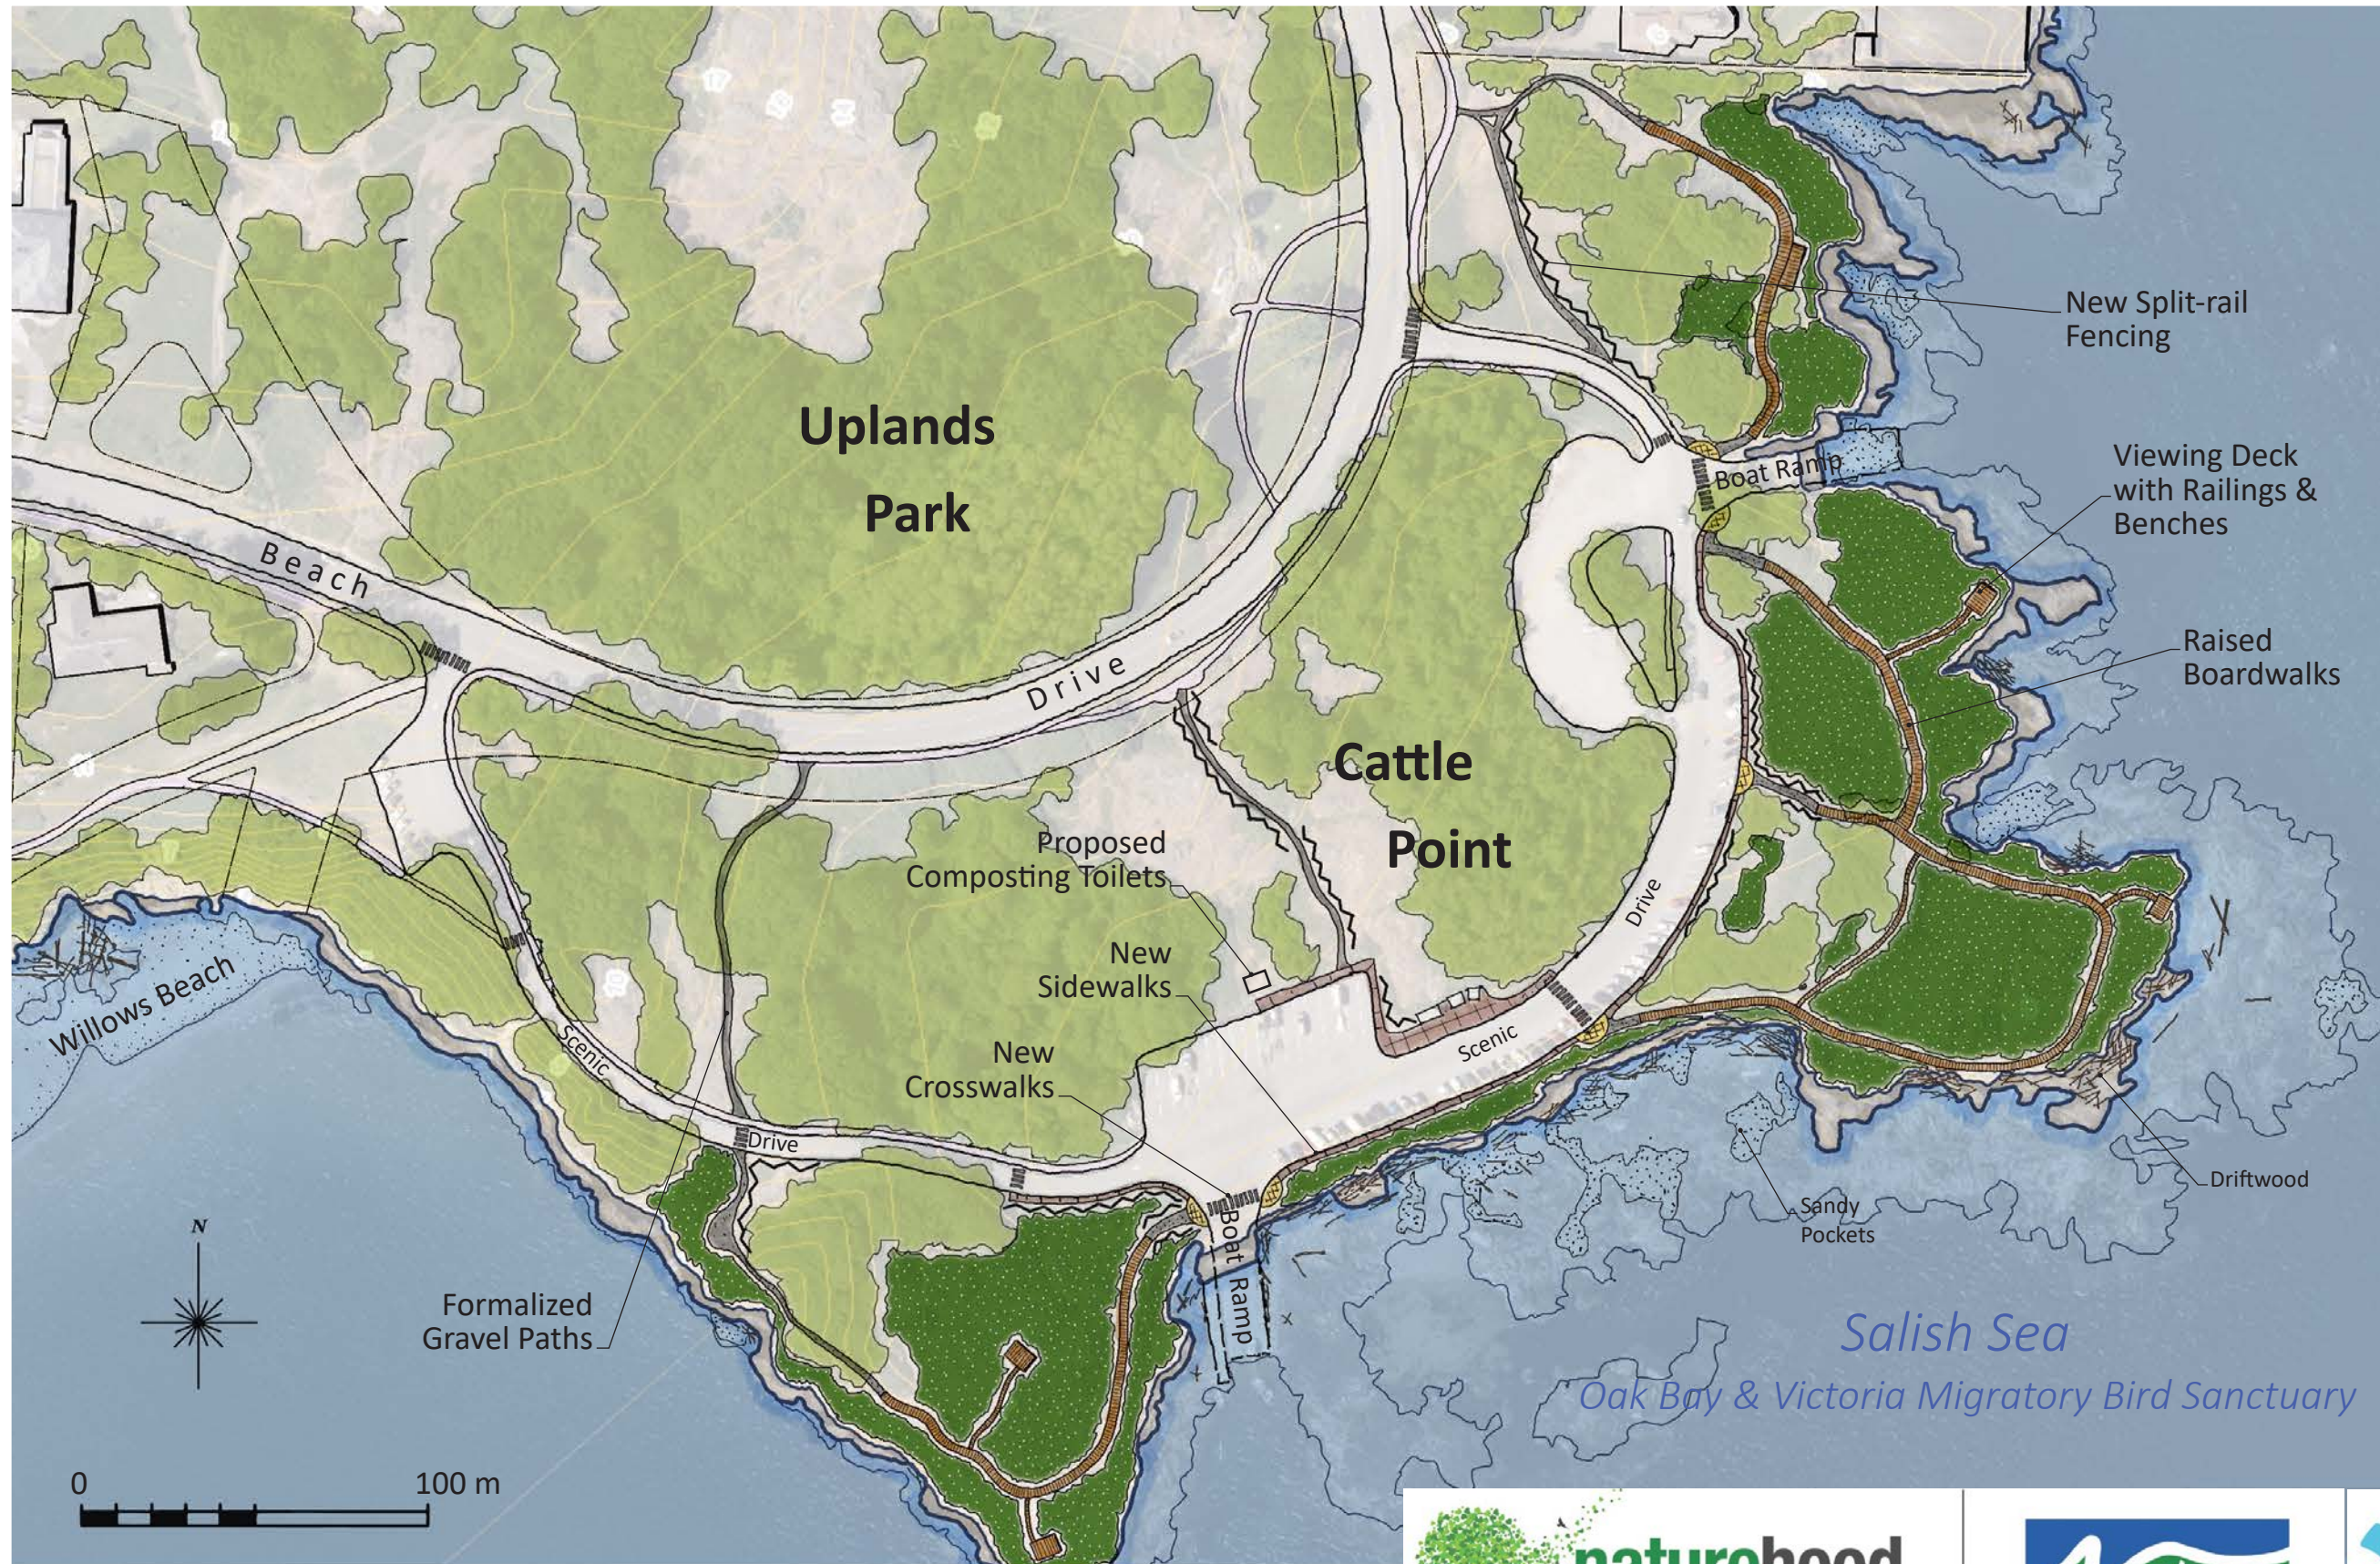
- Existing tree cover
- Maritime Meadow restoration areas

- Maritime Meadow: 2.2 Ha.
- 5' Wide Boardwalk Length: 560 m.
- 3' Wide Boardwalk Length: 130 m.
- 4 Viewing Decks
- Split-rail Fence Length: 350 m.'
- Relocate Benches.

- Formalized Gravel Paths: 450 m.
- 9 Crosswalks with Letdowns.
- New Sidewalks: 400 m.

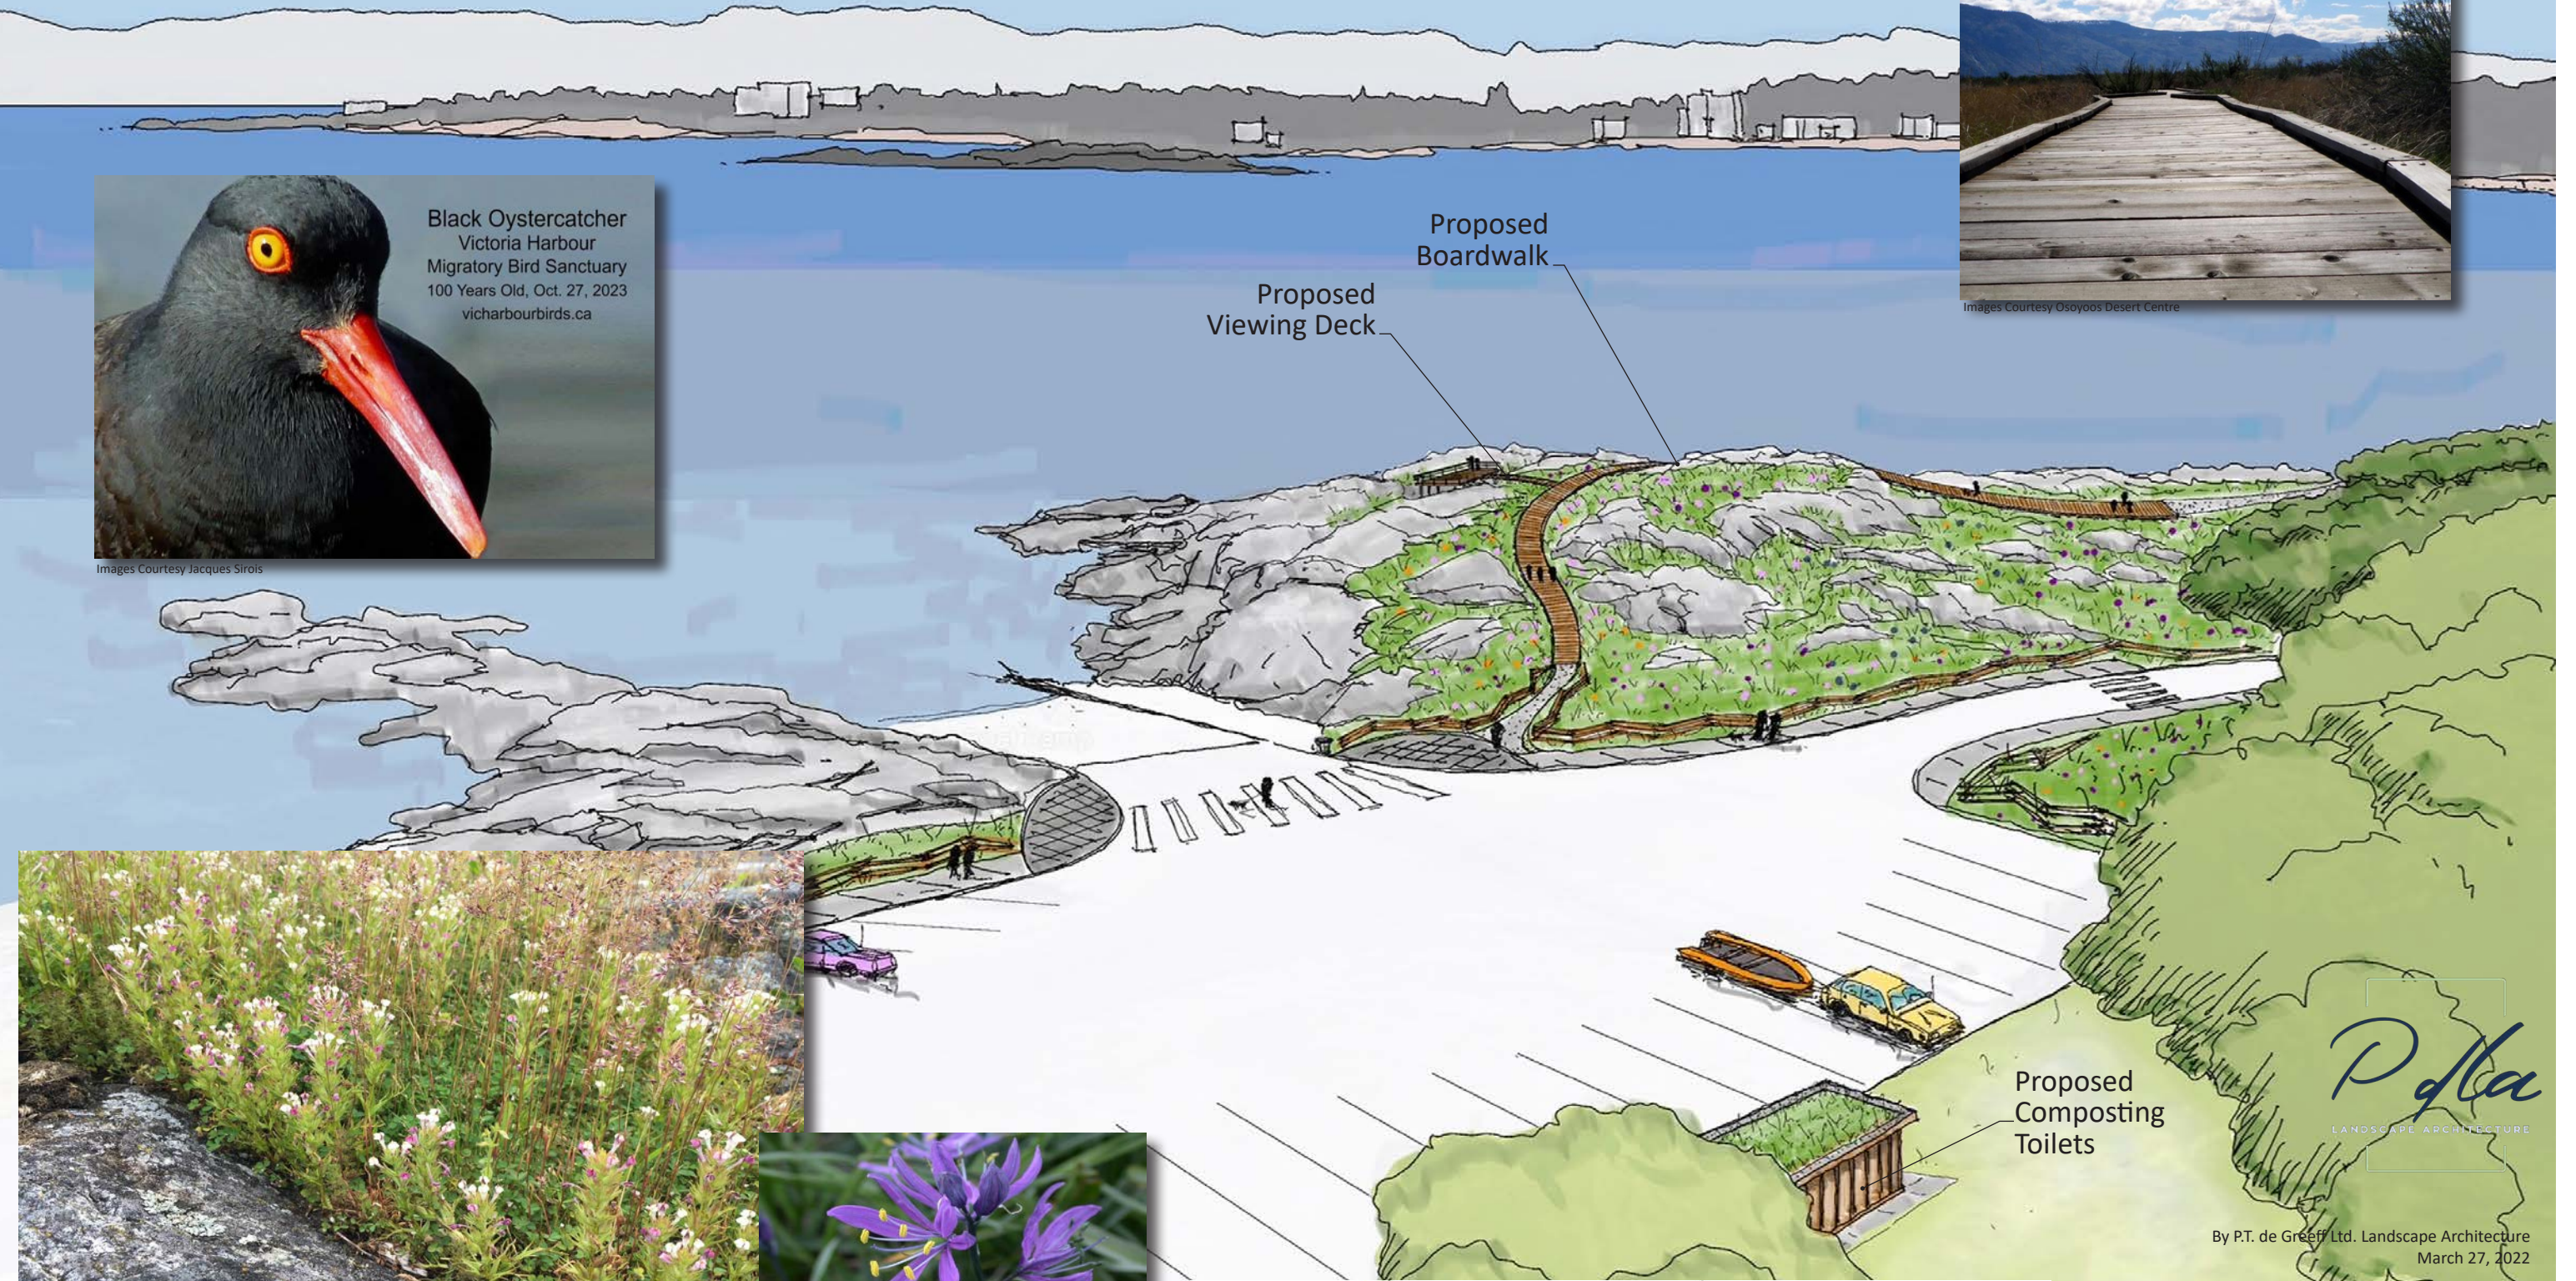
Proposed Boardwalk  
Proposed Viewing Deck

Proposed Composting Toilets
